DEPARTMENT OF TRANSPORTATION**DIVISION OF ENGINEERING SERVICES**

Contract #: 04-0120F4Cty: SF/ALA Rte: 80 PM: 13.2/13.9File #: 01.28**WELDING INSPECTION REPORT****Resident Engineer:** Casey, William**Address:** 333 Burma Road**City:** Oakland, CA 94607**Report No:** WIR-030035**Date Inspected:** 12-Sep-2013**Project Name:** SAS Superstructure**OSM Arrival Time:** 700**Prime Contractor:** American Bridge/Fluor Enterprises, a JV**OSM Departure Time:** 1730**Contractor:** American Bridge/Fluor Enterprises, a JV**Location:** Job Site

WELDING INSPECTION REPORT

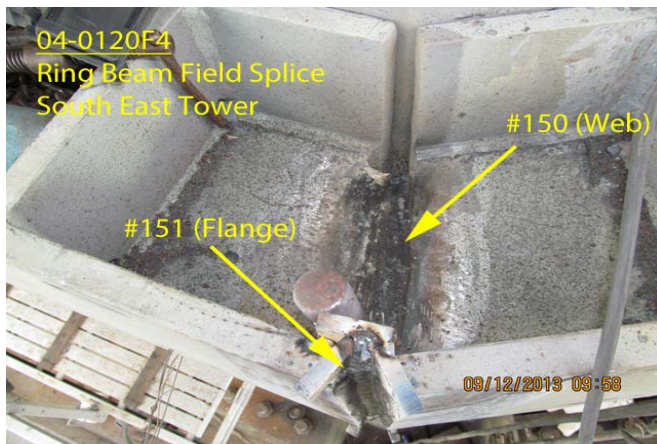
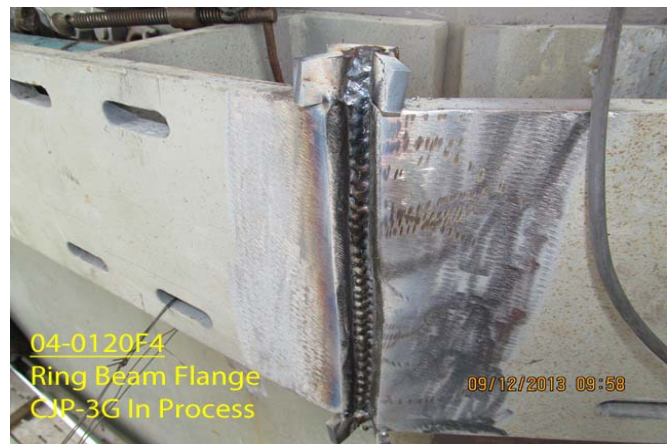
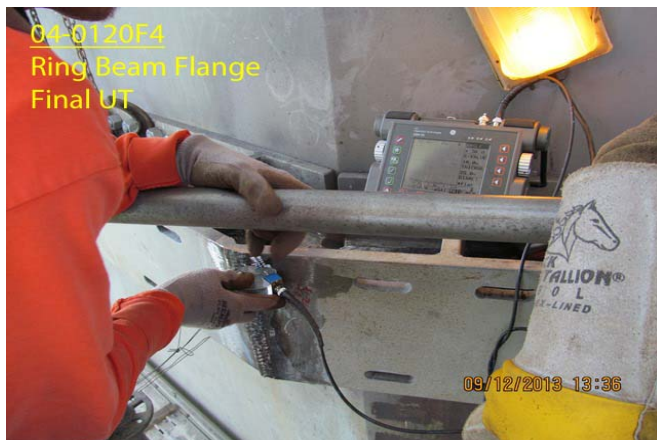
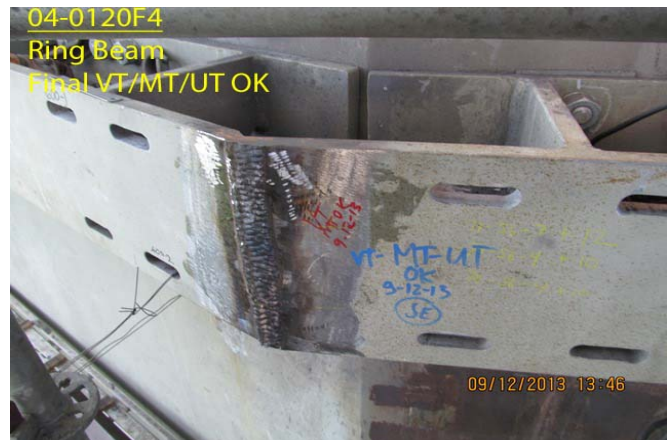
The welding & workmanship observed on this date appeared to be in general compliance with the contract specifications. The following picture images detail the work in progress.
